PROGRESS UPDATE
MAY 2012

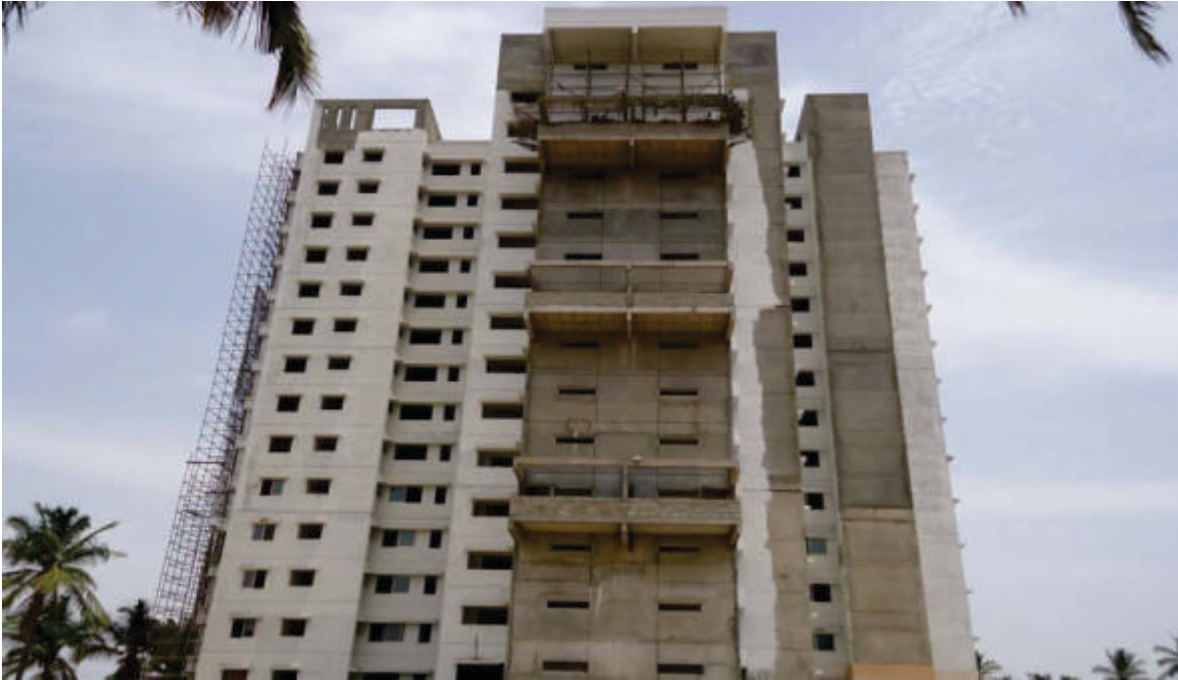
Tower C from East side.

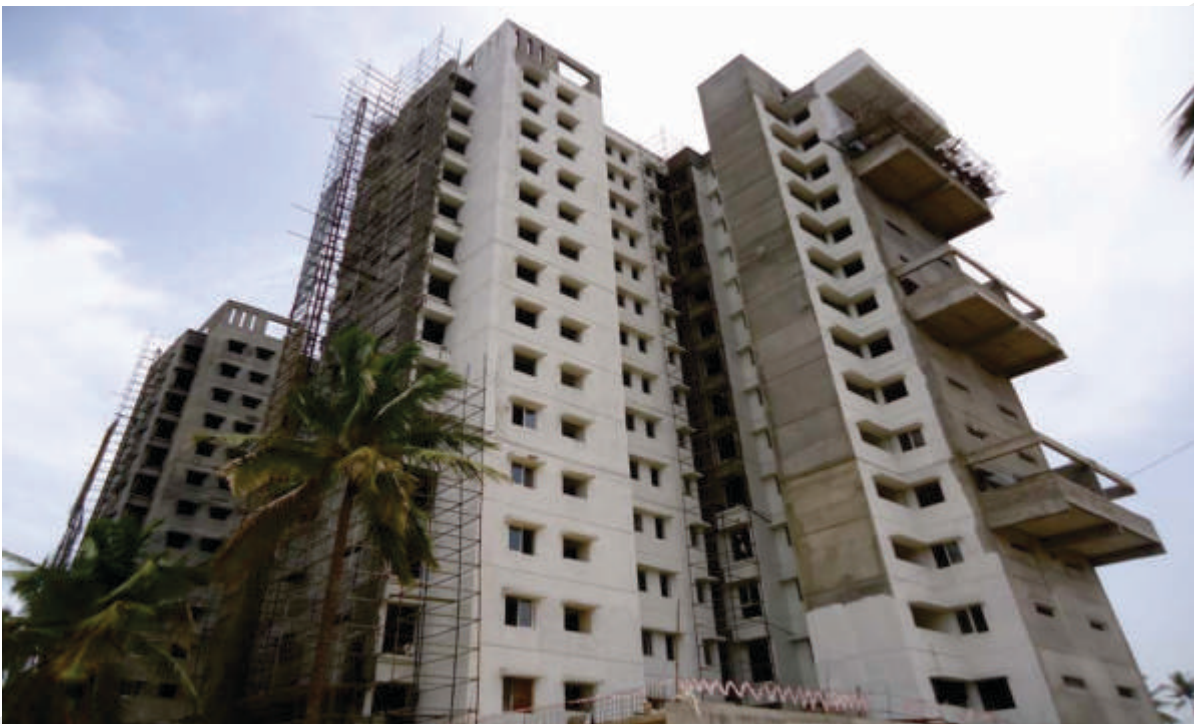
Tower C view from South East Corner.

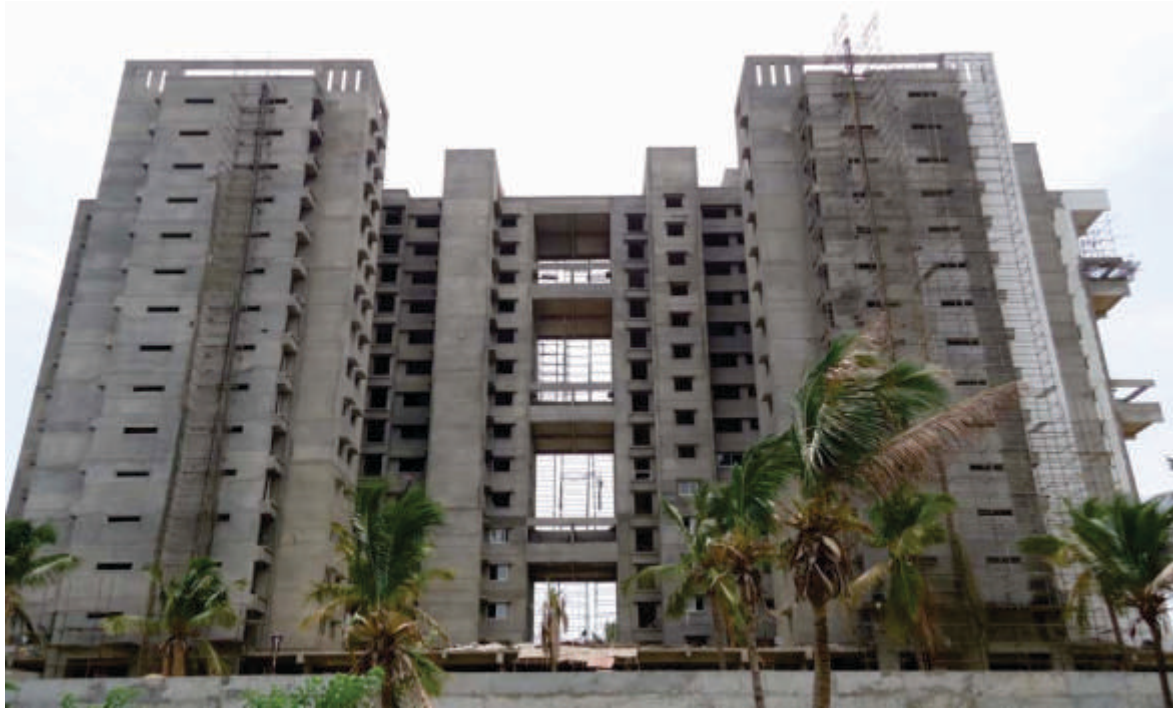
Both Tower C and D from South side.

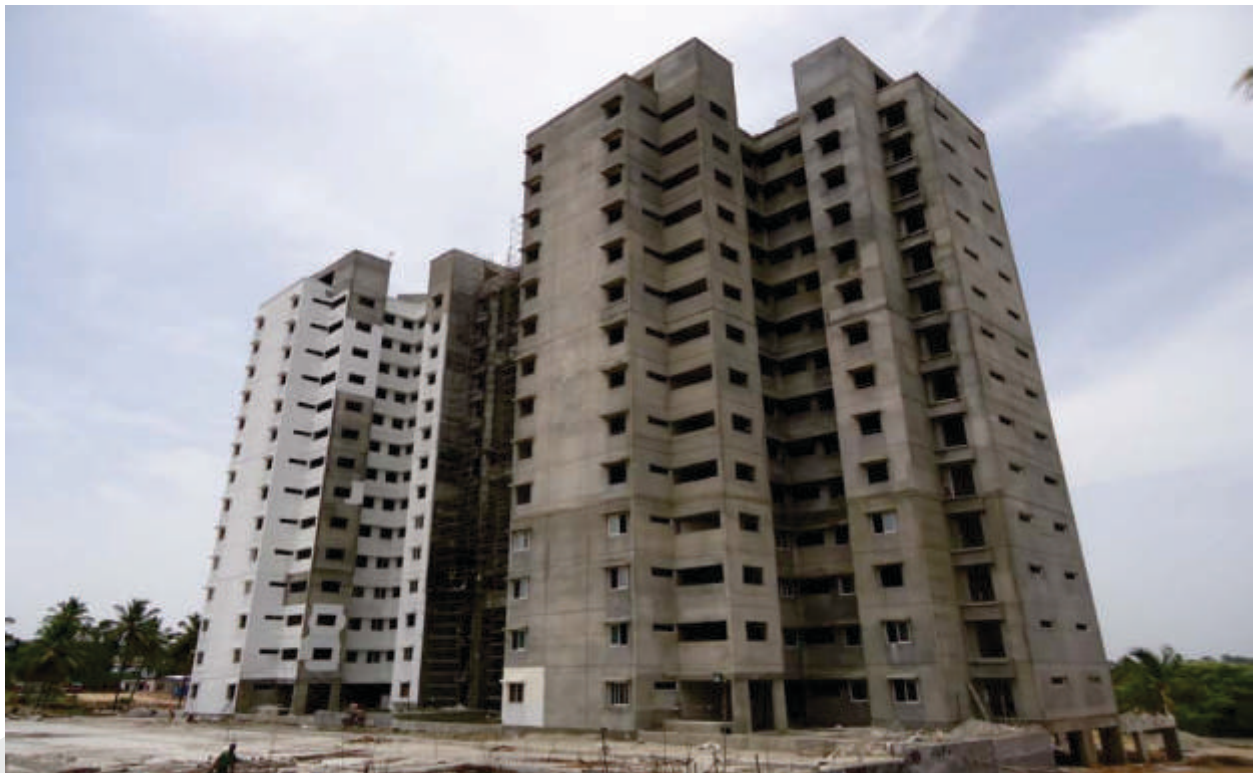
Both Tower C and D from North west Corner.

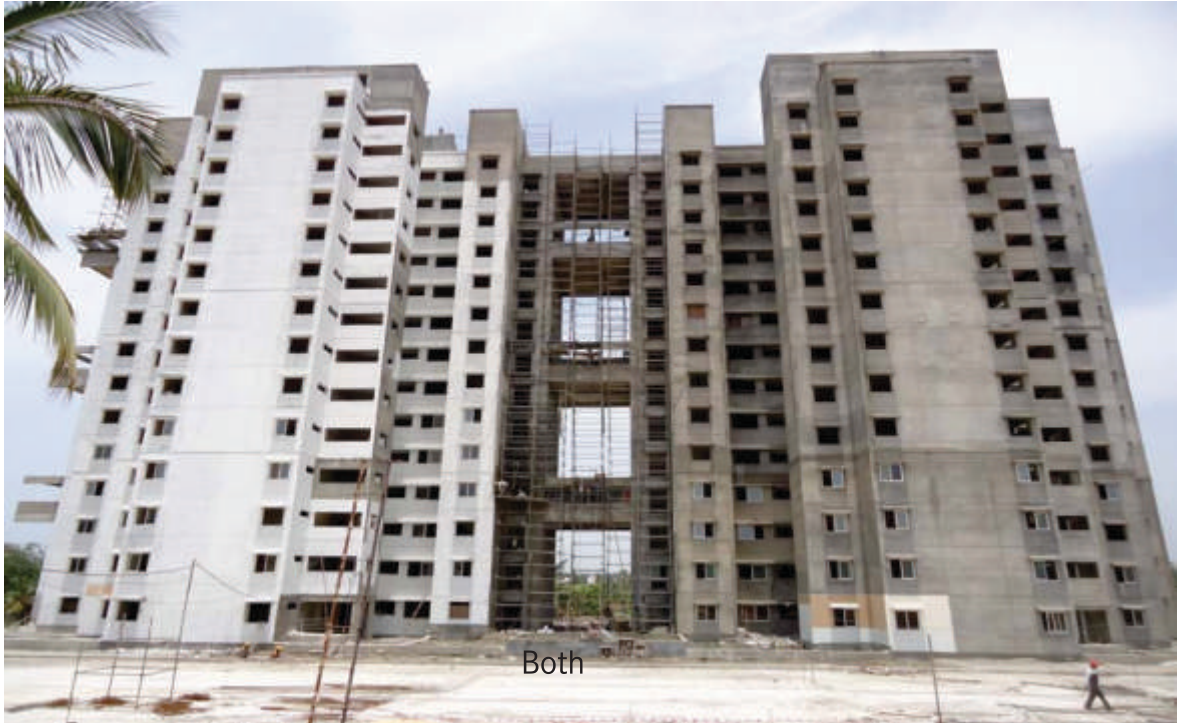
Both

Tower C and D from North side.

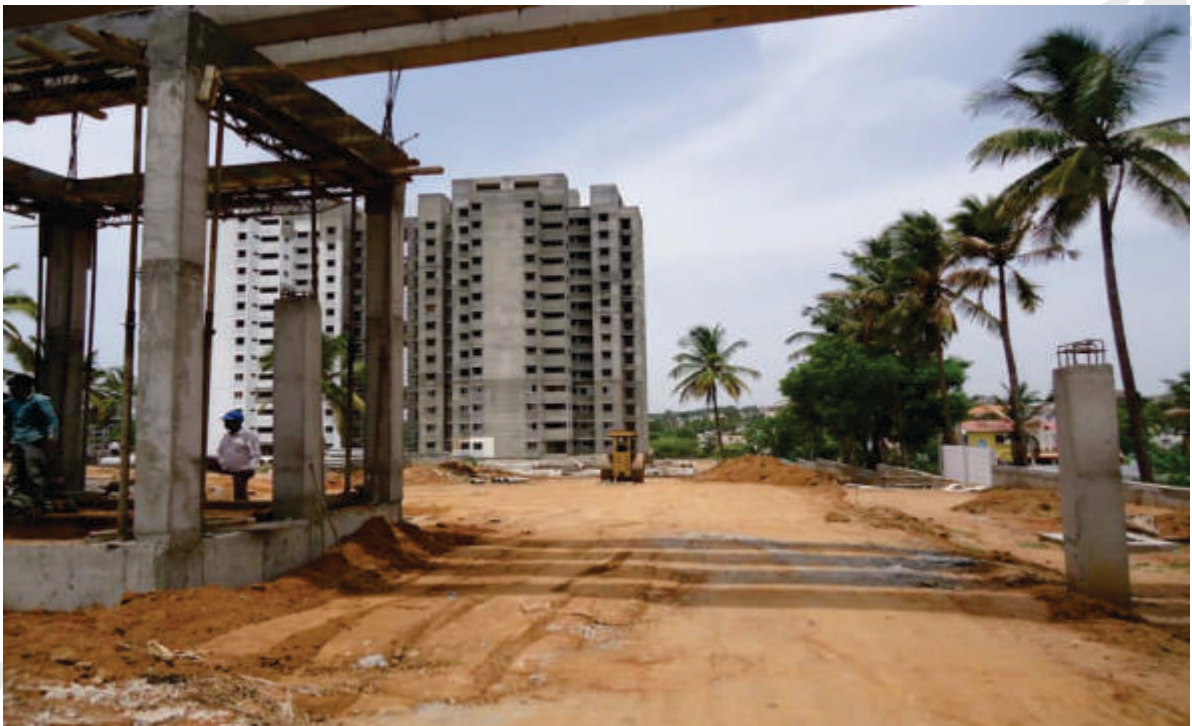
Road Formation Works

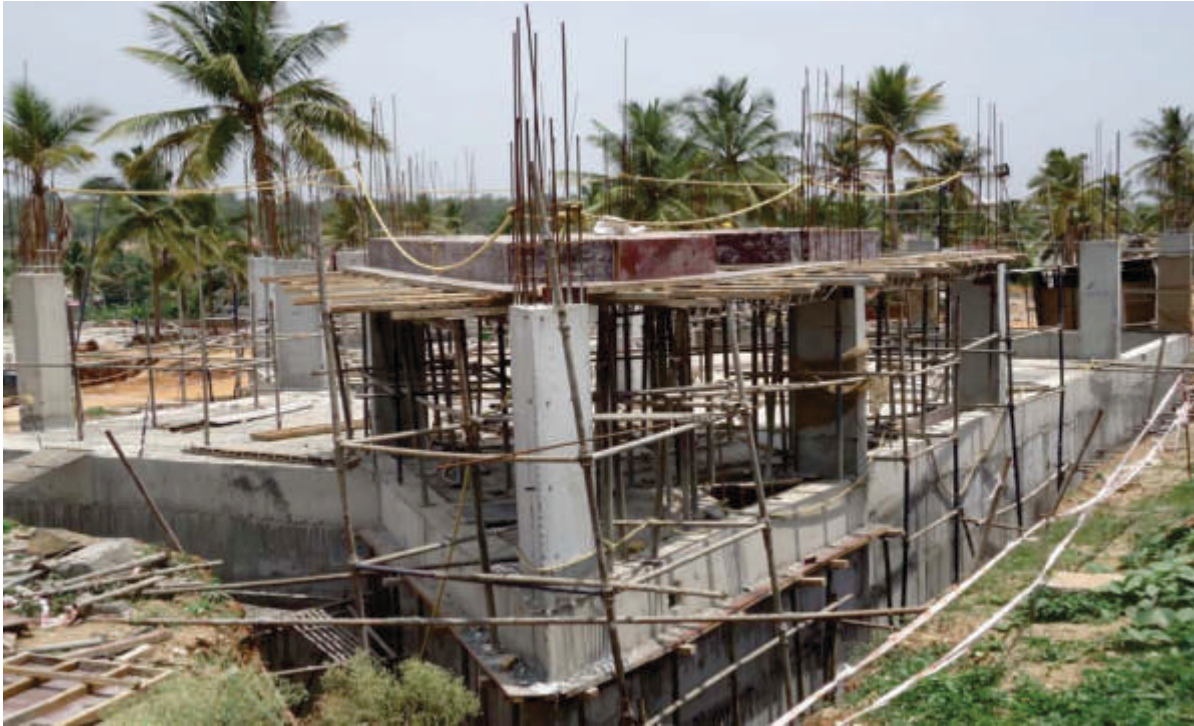
Club House First floor slab shuttering in progress

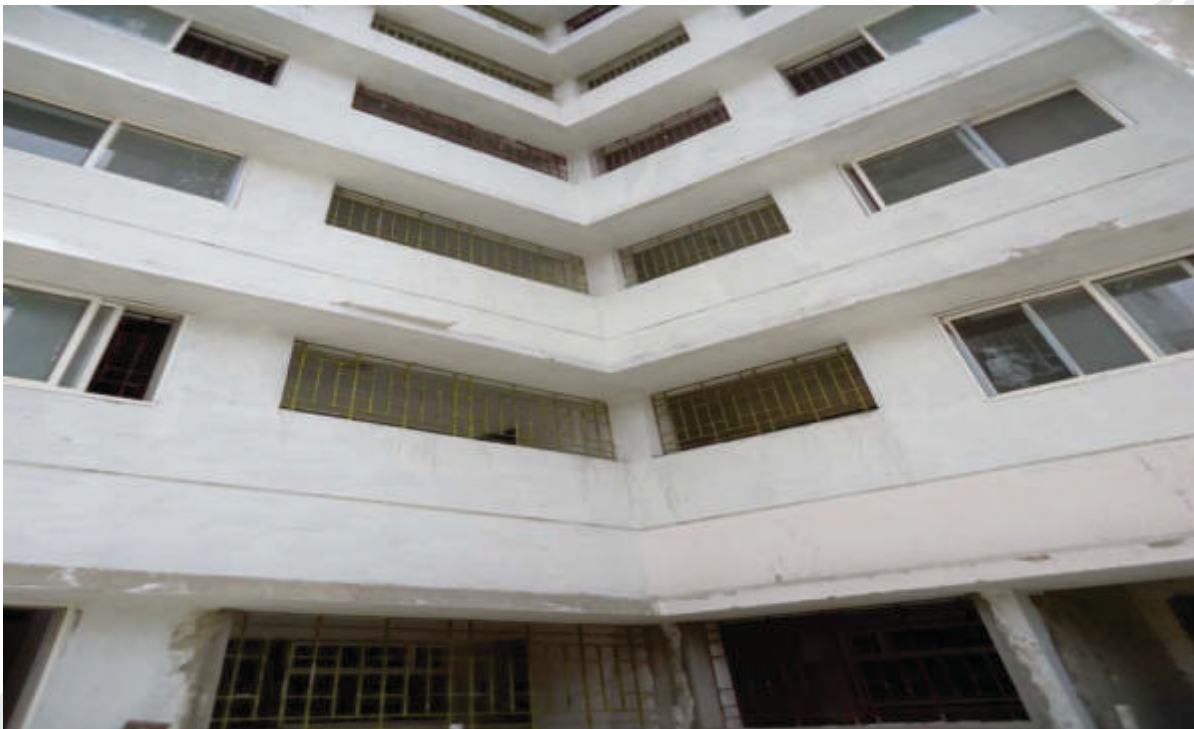
Fixing of Window, Utility grills and Aluminium windows are in progress

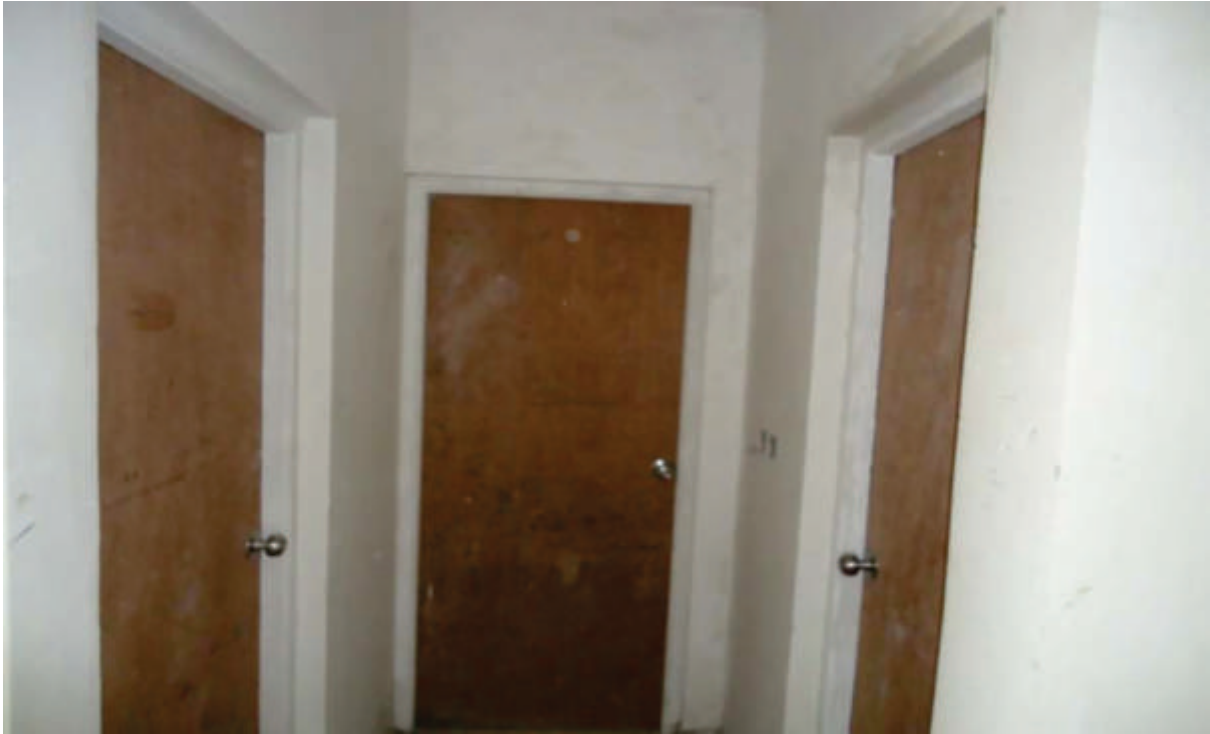
Fixing of Internal door shutters in progress.

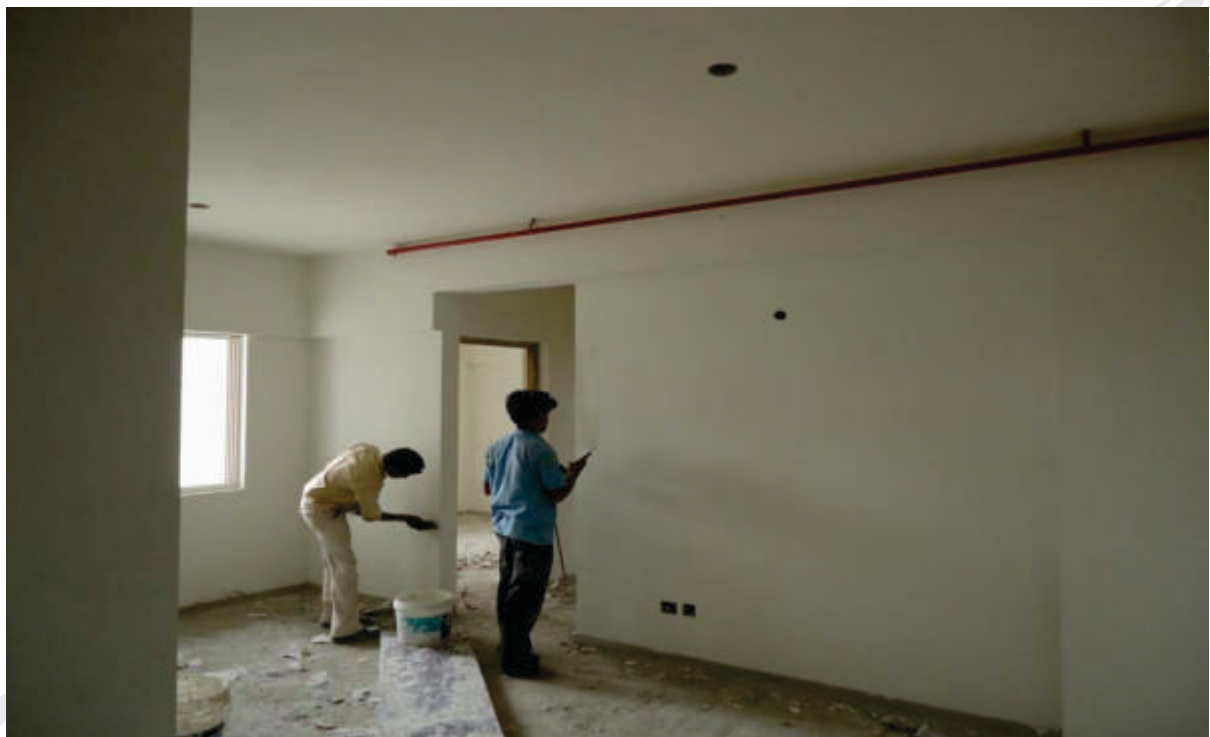
Internal Painting(Primary putty works are in Progress).

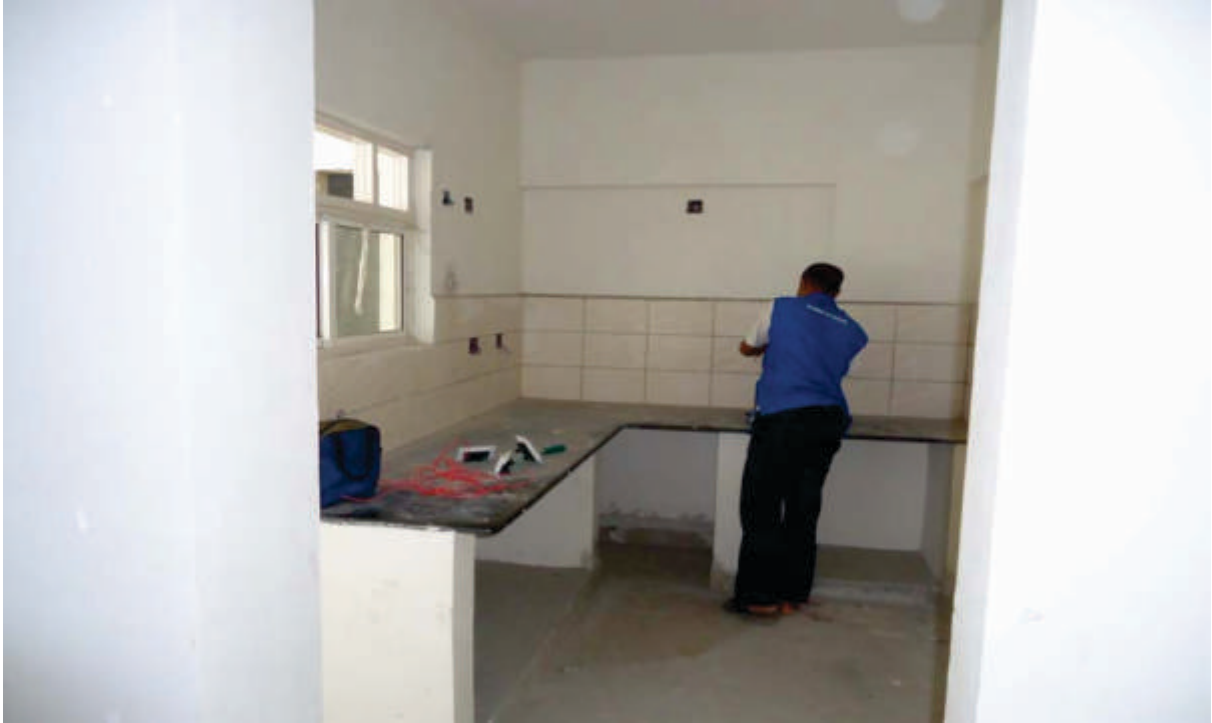
Internal wiring works are in progress
